Manhole Inspection Summary

Manhole # S13UU1008MH

Insp Date: **6/23/07 7:45 PM**

Location Address: **NORTHERN PKWY**

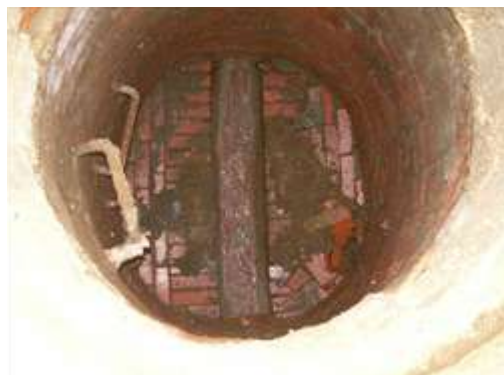
Top View

Steps Count: **3** Missing: **0** ☒ **Corroded**

Surcharge ☒ **Evidence Of Surcharge** Depth: **2** (ft.) ☐ Active Surcharge Present

Evidence of surcharge - Bench debris.
Corroded steps.

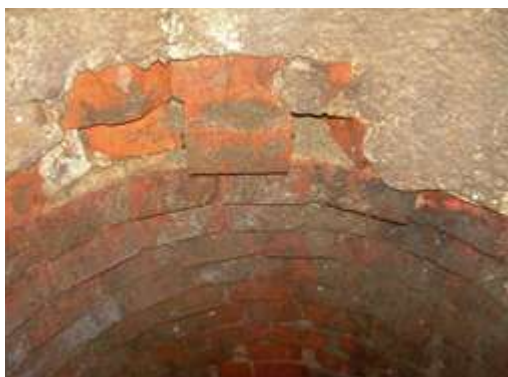
Defect

Condition: ☐ Sound ☐ Cracked ☐ Root Intrusion ☒ **Loose Brick** ☒ **Deteriorated**

Infiltration: ☐ None ☒ **Joint** ☐ Cracks ☒ **Mortar** ☐ Roots ☐ Wall

Adjustment deterioration, loose brick, and infiltration.

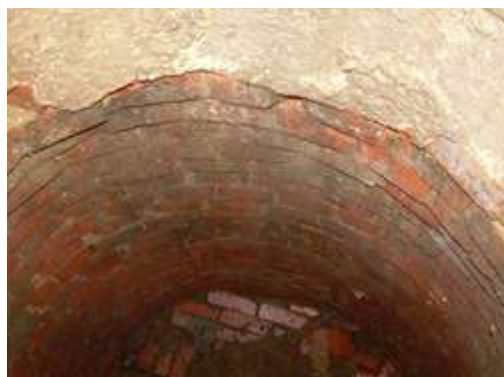
Defect

Infiltration: ☐ None ☐ Joint ☐ Cracks ☒ **Mortar** ☐ Roots ☒ **Wall**

Adjustment, Corbel, and Barrel infiltration.

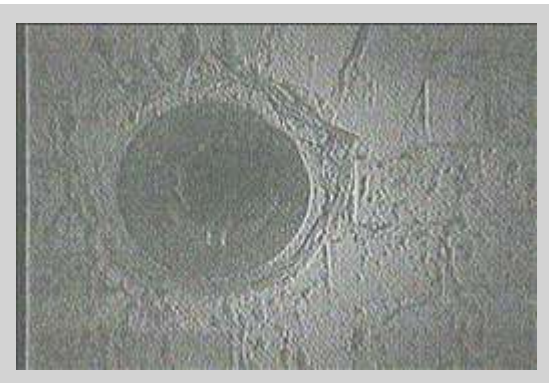
8 in. Circular Gravity Sewer Pipe In @ 6 O'Clock

Infiltration: **None** Pipe Seal Cond: **Cracked**

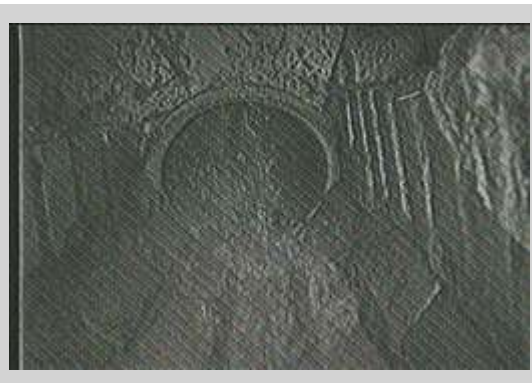
Drop In @ 6 O'Clock

Condition: ☐ Sound ☐ Cracked ☐ Root Intrusion ☒ **Deteriorated** ☐ Leaks ☐ Debris

Channel deterioration.
